## CHURCHVIEW COMMONS

### PRELIMINARY GEOTECHNICAL ASSESSMENT

**February 2022**

**YOUNG & ASSOCIATES | ENGINEERS • SURVEYORS  
2039 SOUTH 6<sup>TH</sup> STREET · INDIANA, PA 15701  
PHONE: 724-463-7090  
FACSIMILE: 724-463-7092**

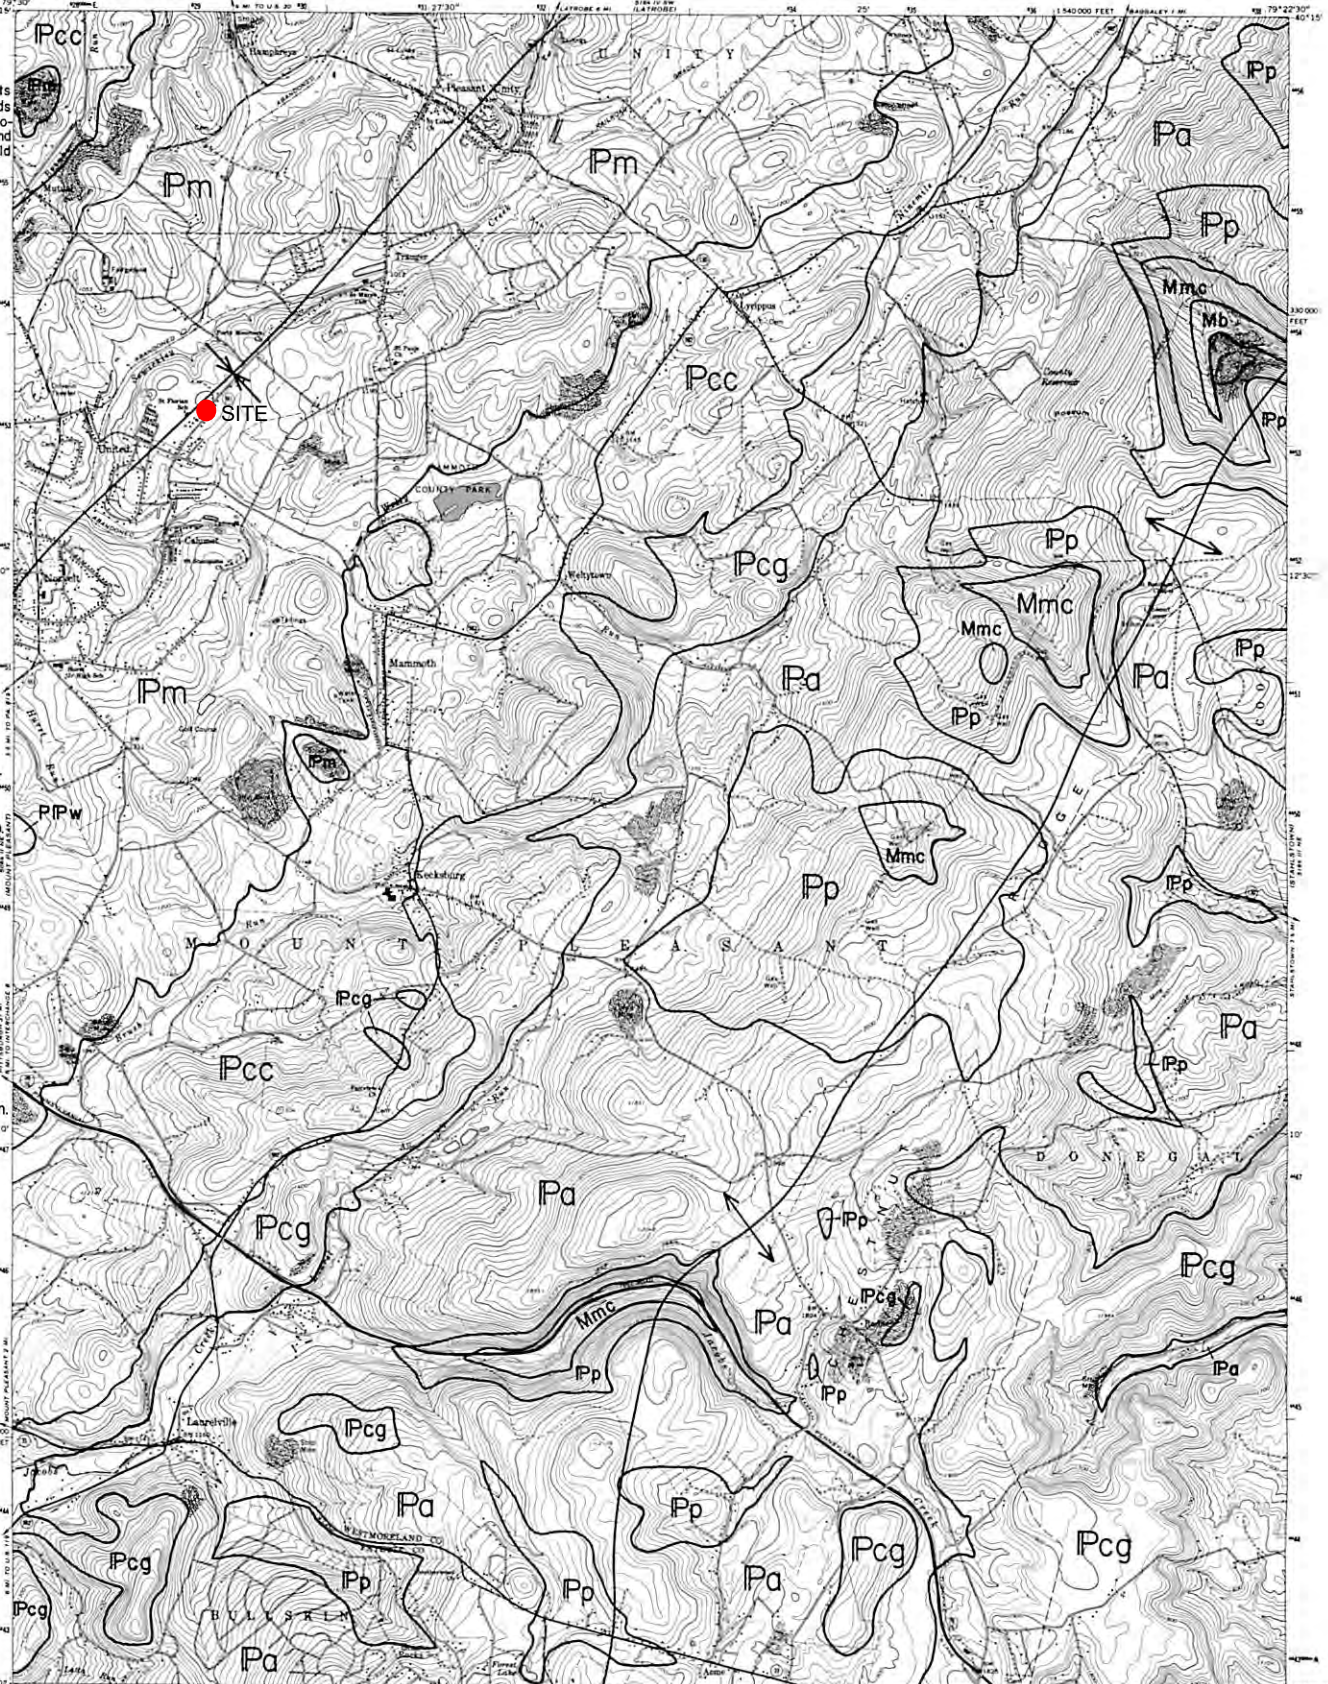
## **Surface Geology Map**

Structurally, the underlying bedrock fold plunges shallowly to the southwest. Regionally this synclinal is known to be the Uniontown-Latrobe Syncline. Stratigraphically, as shown on the Geologic Map of Pennsylvania, the project site is located within the Pennsylvanian-Aged Allegheny Group. This unit typically consists of cyclic sequences of shale, siltstone, sandstone red beds, thin impure limestone and continuous coal seams.

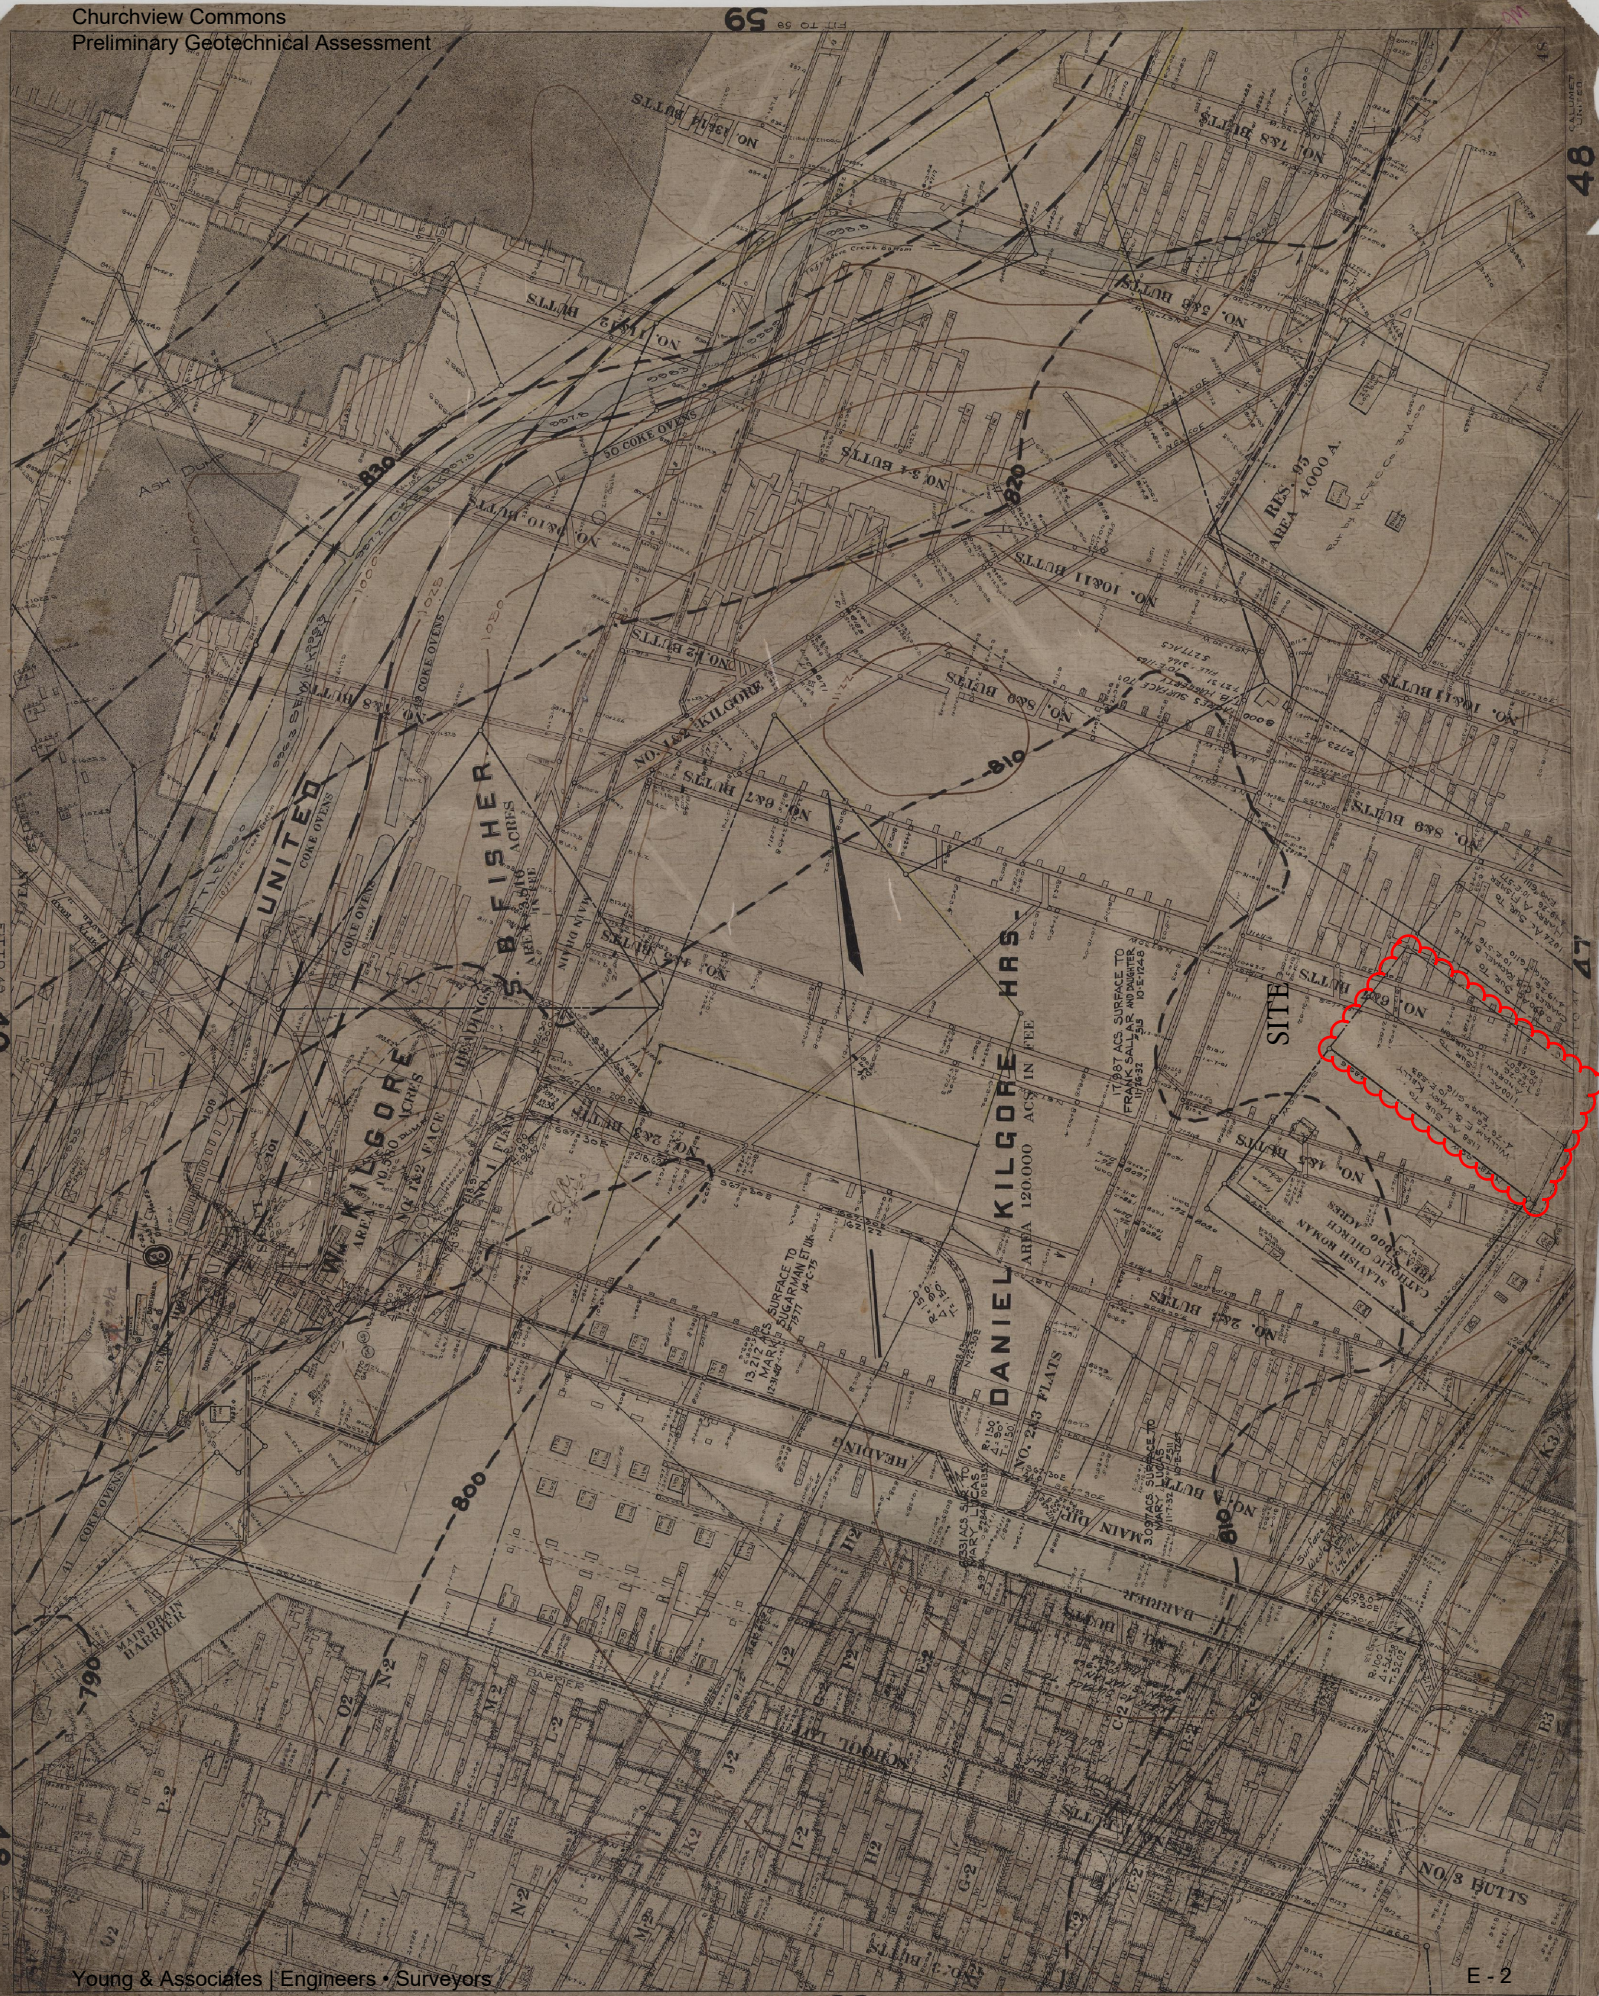
## Mine Map

- I. **Mining:** Based upon data from online assessment, the property has been undermined in the Pittsburgh Coal Seam. Mining was performed by the HC Frick Coke Company Calumet-United Mine complex. The mine map lists the bottom of coal elevation to be 810-815 msl (datum unknown). A single heading is shown on the available mine map with low percentage extraction. The depth of the mine voids is approximately 300 feet with room and pillar style of mining. Extraction percentages are depicted as less than 50% mining. A portion of the mine map with the project area highlighted is attached as Appendix E. No current mining permits exist in the area.

Based upon data from online assessment, deep mining has been reported under this Site. No current mining permits exist in the area. The potential for subsidence from deep mining is low.

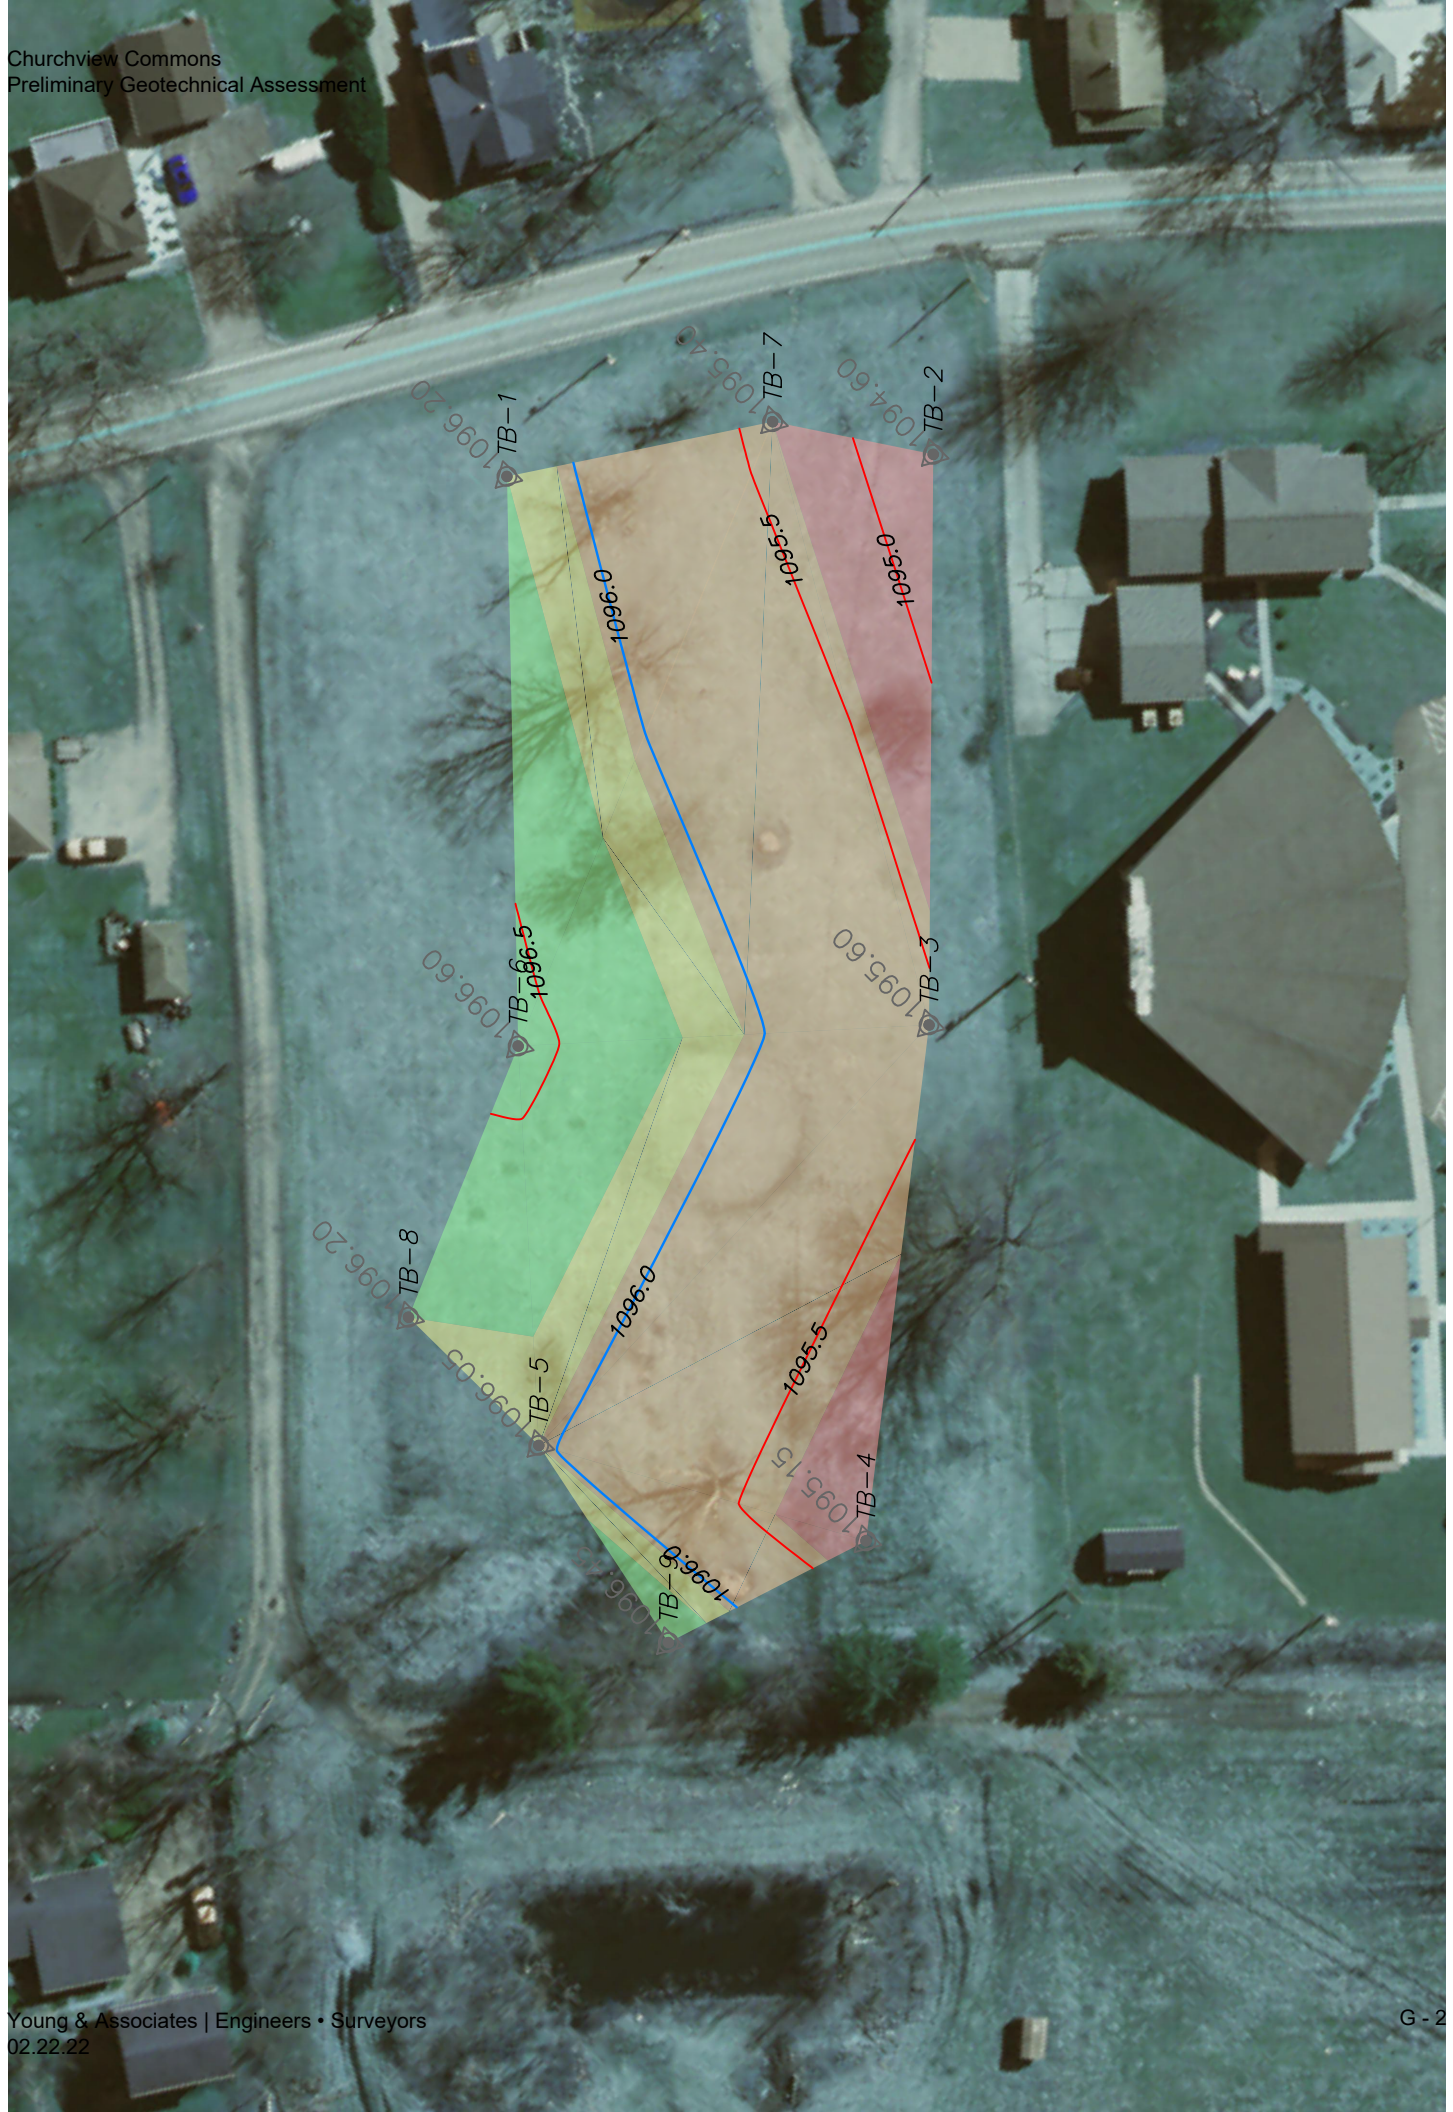
## Rock Profile

**Bedrock:** Bedrock was encountered in each of the borings at auger refusal. [3] borings, TB-7, TB-8, and TB-9 were cored to assess the condition of the rock. This rock is comprised of two district units: light gray sandstone and brown-gray silty shale.

**Sandstone:** This material was identified at 5.0-5.4 and 7.1-7.9 in TB-7, 5.0-5.4 and 9.0-10.0 in TB-8, and 5.0-6.1 and 10.4-11.5 in TB-9. In each of these instances the rock was thinly bedded, broken with oxidation streaks on bedding planes. Very small non-horizontal fractures are rare but do occur in small zones. These are presumable joints from non-plastic bending. RQD values were 0-10 with most fractures along fluid migration bedding planes. Recovery of the core material was low.

**Silty Shale:** This material was identified at 5.4-7.1 and 7.9-10.0 in TB-7, 5.4-9.0 in TB-8, and 6.1-10.4 in TB-9. In each instance the shale is highly weathered, broken and soft. Most of this rock was able to be crushed under finger pressure. RQD value for this unit is 0. It also shows strong oxidation from fluid migration. Recovery of the core material was low.
